**FEDERAL ENERGY REGULATORY COMMISSION
FIELD INSPECTION REPORT**

Date March 1, 2012

Project Tennessee Gas Pipeline Company (TGP)
300 Line Project
Sussex and Passaic Counties, New Jersey and Potter, Tioga, Bradford,
Susquehanna, Wayne, and Pike Counties, Pennsylvania
Docket No.: CP09-444-000
Authority: Section 7(b) and (c) of the Natural Gas Act and the certificate
procedures of Part 157, Subpart F

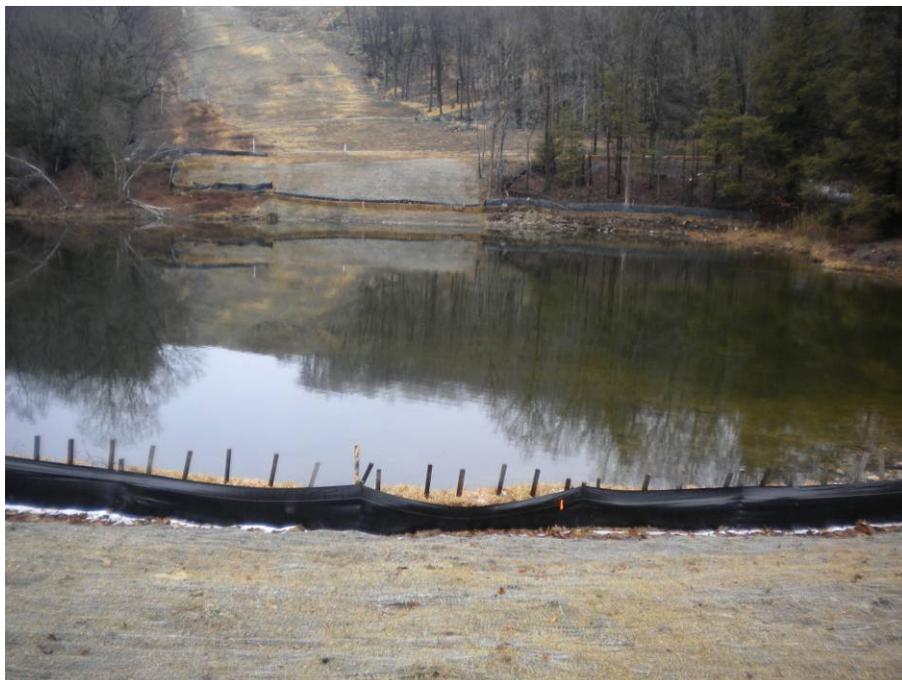
Photo No.: 1

Comments: Bearfort Waters – banks appeared stable. Some revegetation had occurred. All ECD's were functioning, with the silt fence in the foreground needing some minor repair.

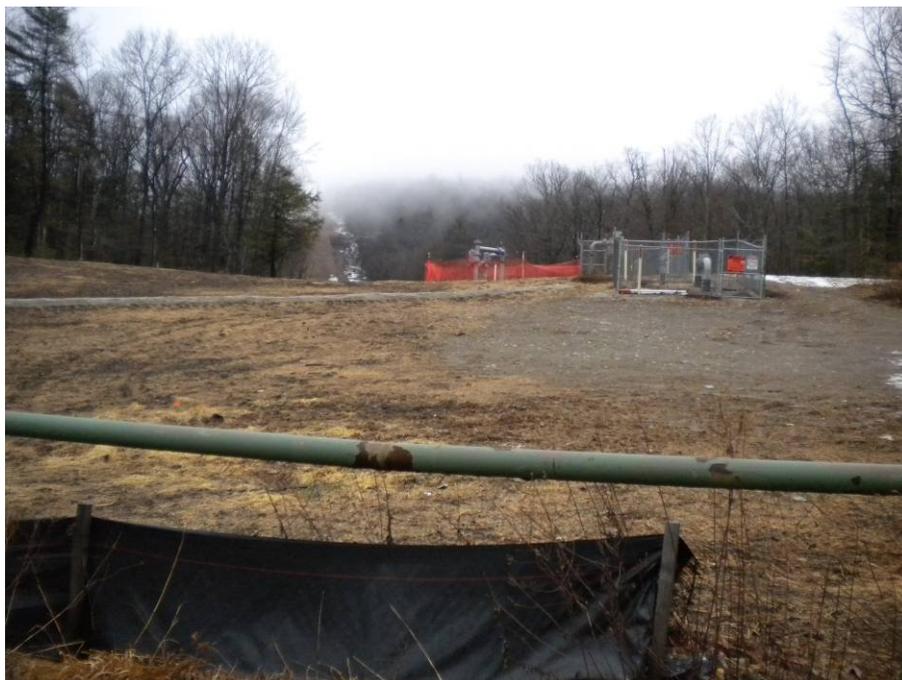
Photo No.: 2

Comments: Adjacent right-of-way to Bearfort Waters. Some revegetation had occurred. All ECD's were functioning. Restoration proceeding satisfactorily.

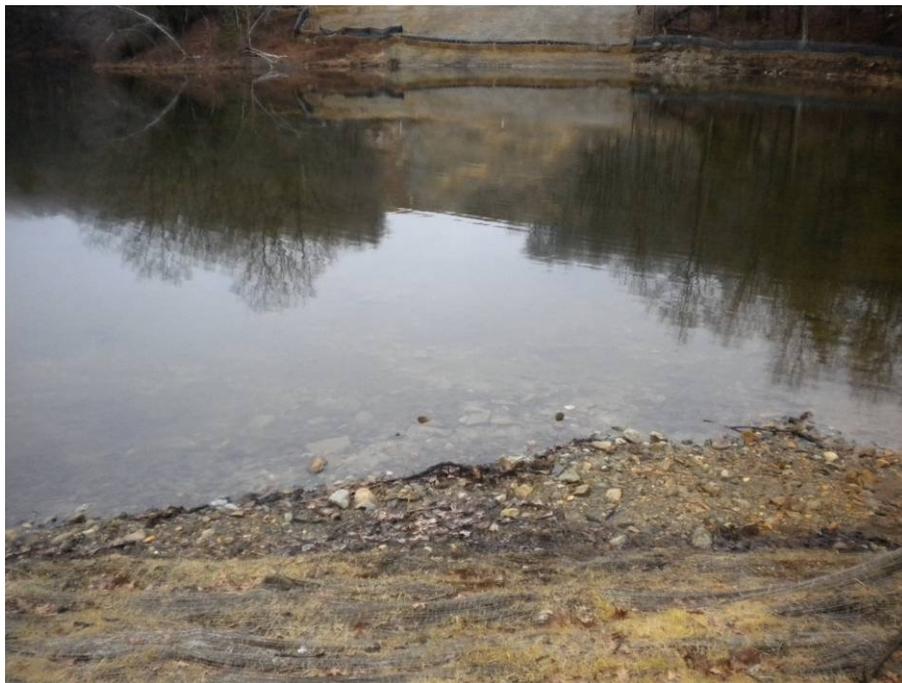
Photo No.: 3

Comments: Bearfort Waters – No noticeable turbidity. Lake bottom appeared stable.

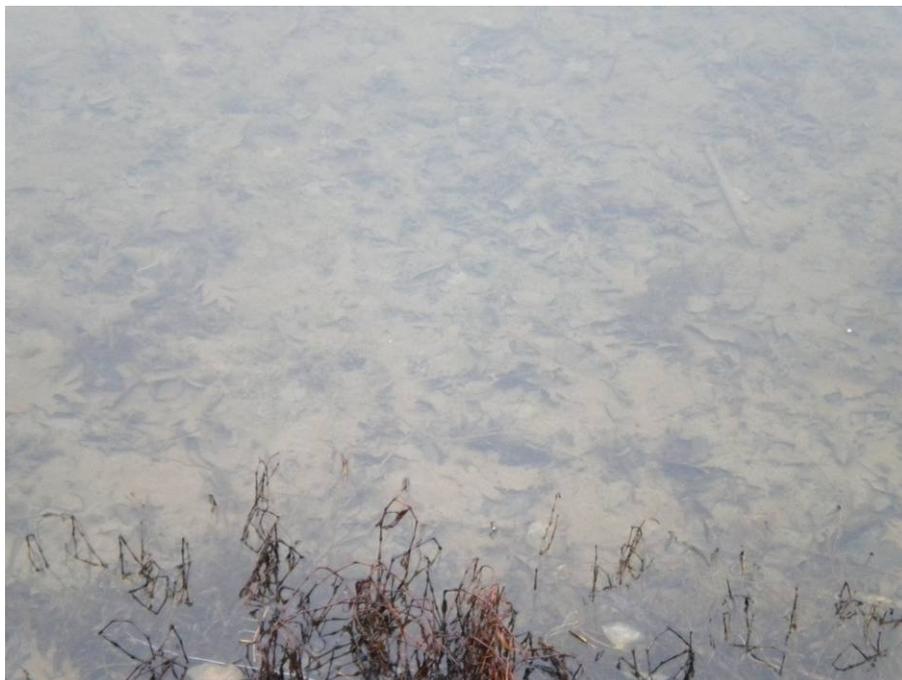
Photo No.: 4

Comments: Lake Lookover – No turbidity noted at time of inspection.
